# Manhole Inspection Summary

Manhole # S150O1014MH

Insp Date: **11/18/06 8:53 AM**

**Location** Address: **4891 YELLOWWOOD AVE** Cross Street: **SUNDEW TERR**

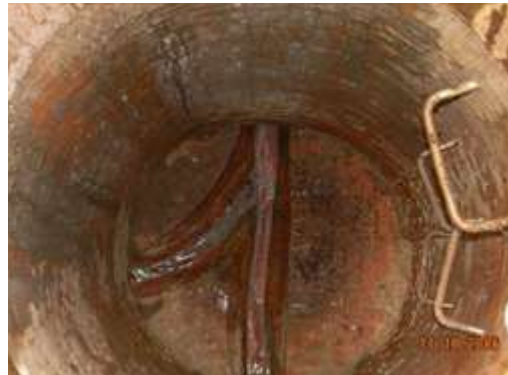
Top View

**Bench** ☒ Exists Material: **Brick** ☐ Parged ☒ **Debris** (not Condition related)  
Condition: ☒ Sound ☐ Cracked ☐ Root Intrusion ☐ Deteriorated ☐ Leaks ☐ Debris

**Steps** Count: **5** Missing: **0** ☒ **Corroded**

Corroded steps. Bench debris.

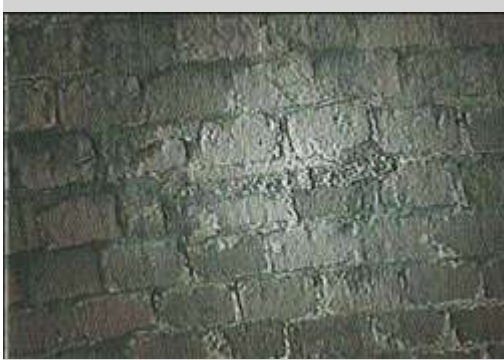
Defect

Barrel infiltration.

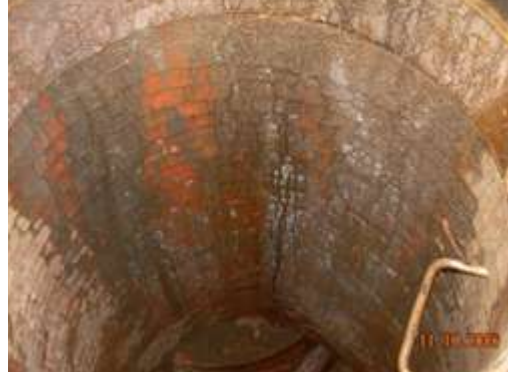
Defect

**Frame** Offset: **0** (in.) Condition: ☐ Sound ☐ Cracked ☒ **Leaks**

**Chimney / Frame Adjustment** ☒ Exists Material: **Brick** ☐ Parged Height: **3** (in.)  
Condition: ☒ Sound ☐ Cracked ☐ Root Intrusion ☐ Loose Brick ☐ Deteriorated  
Infiltration: ☐ None ☒ **Joint** ☐ Cracks ☐ Mortar ☐ Roots ☐ Wall

Frame leaks. Adjustment infiltration.

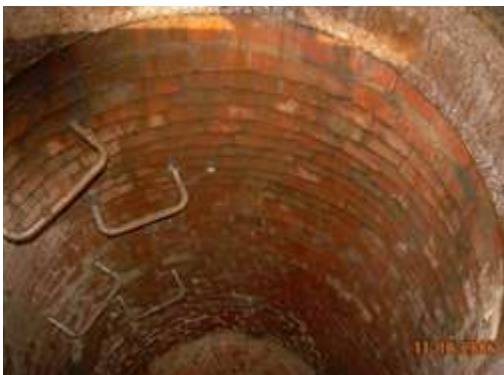
Defect

Frame leaks. Adjustment and Barrel infiltration.

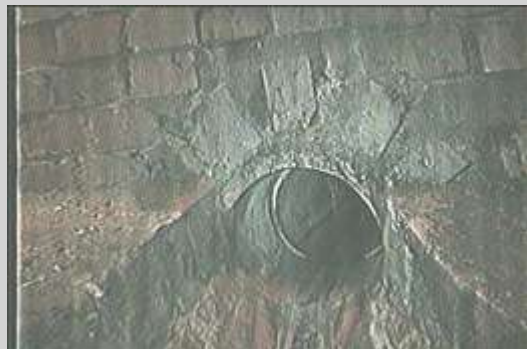
8 in. Circular Gravity Sewer

Barrel deterioration and infiltration.
